TECHNICAL BULLETIN

HOLDEN CRUZE JG SERIES – CAMSHAFT SENSOR RELATED FAULT CODES

Holden Cruze JG 2009-2011

Engine F18D4 1.8L

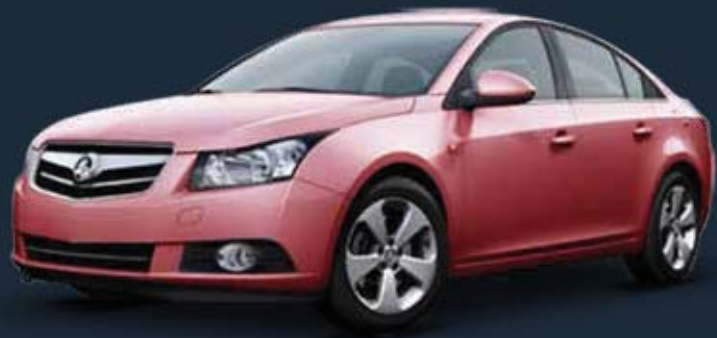
**Camshaft sensor fault codes:
P0340, P0341, P0365, P0366**

Camshaft codes are mostly associated with a faulty cam sensor, wiring & or ECM. As previously mentioned in earlier tech article, the Cruze ECM's (F18D4) are also very common for water damage.

In this instance the ECM is logging fault code/s for the camshaft sensor, it does not necessary mean that the camshaft sensor/s, wiring or ECM are at fault. The fault codes can be due to incorrect timing belt installation procedure.

The camshaft sprockets in the Holden Cruze F18D4 engine are not key way located to the camshafts. They rely on the camshaft sprocket retaining bolt tension to maintain the camshaft sprocket to camshaft alignment. If the camshaft sprockets or camshaft move or are forced, (it may be only a few degrees) by trying to rotate the sprocket/s during a timing belt installation, the ECM will see a mismatch between the crankshaft & camshaft sensors signals & log a camshaft sensor code.

During any timing belt removal/installation, the use of special alignment tools is required.
