TECHNICAL BULLETIN

Document number: T0008

Model: EA MPI

Subject: Acceleration problems

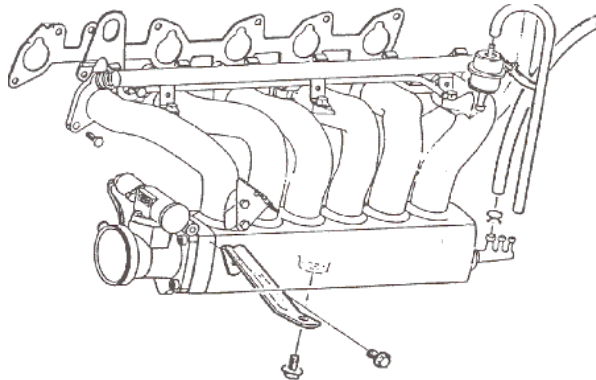
It has been found that the vehicle has had head or manifold work and the manifold re-assembled with a new gasket. However in these cases a CFI gasket was fitted instead of a MPI gasket. The CFI gasket does not have the cutaway for the injectors, so half the injector hole is covered which affects the spray pattern. If you suspect this, it may be quicker to remove the fuel rail and one injector. You can then see if the gasket is partially blocking the fuel injector hole (cutaway).
