TECHNICAL BULLETIN

Document number: T0011

Make: Ford

Subject: Hall sensor identification

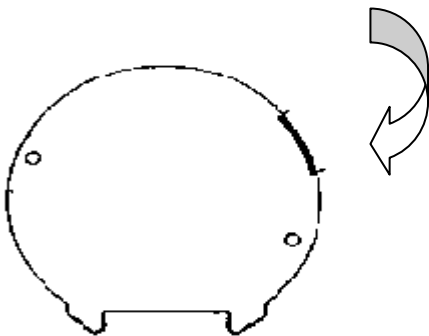
XF EFI (ECCIV) Hall Sensor plate

Bosch Part number 9 233 067 041

Hall sensor location

Although the ignition timing can be set correctly with the incorrect hall sensor fitted, the EFI engine will idle fine but when revved up, it will misfire as the rotor button will not be aligning correctly with the relevant post inside the distributor cap. By removing the spout connector which eliminates any ECM ignition timing advance, the engine can be revved up freely.

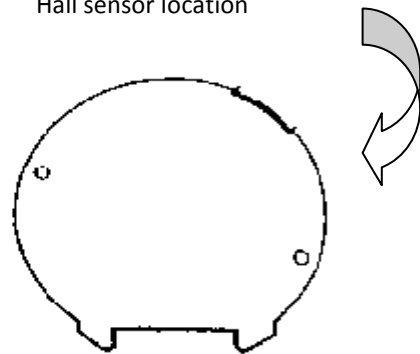
XF EST Hall Sensor plate

Bosch Part number 9 233 067 050

Hall sensor location
