TECHNICAL BULLETIN

Document number: T0029

Make: Ford

Subject: Ignition coil

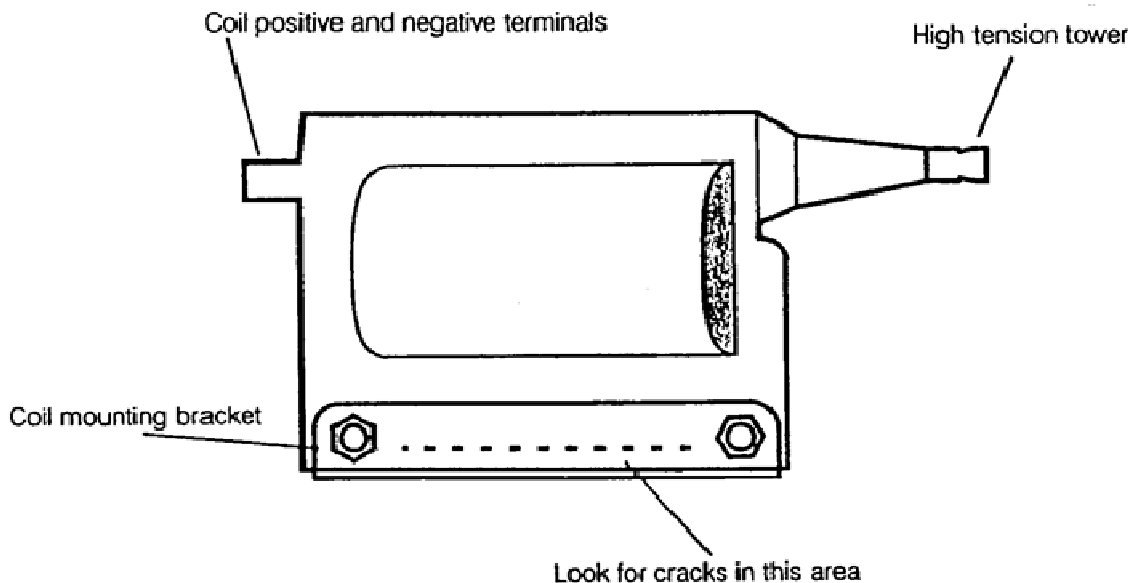
Injectronics have found that an intermittent miss fire in Ford EA - ED 6 cylinder engines, especially under load or in damp conditions can often be attributed to the ignition coil.

The windings on these coils are encapsulated and are then enclosed in a plastic casing. Over time, the plastic casing can become cracked under one or both of the coil mounting brackets. These cracks allow high tension current to leak to ground through the bracket. Unfortunately, the cracks in the casing cannot be seen unless the coil and brackets are removed. Another common cause of coil failure is faulty spark plug leads and corroded distributor caps.
