## TECHNICAL BULLETIN

Document number: T0116

Make: Ford

Model: Falcon EL & XH 4.0L

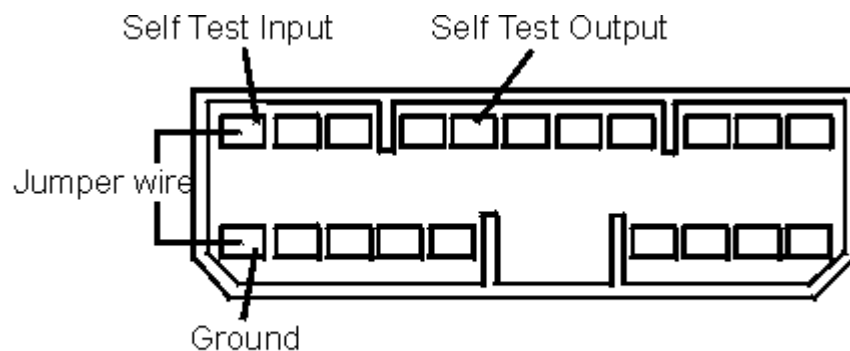
Diagram 1. Data Link Connector

1. The engine must be at the normal operating temperature,
2. A/C must be OFF,
3. Connect a timing light to number one cylinder,
4. With the ignition switch in the off position, bridge the STI & GND terminals in the data link connector (right hand lower dash panel),
5. Start the engine; the Engine Running self-test will cause a momentary rise in engine speed, to 1300-1600 rpm shortly after start-up, this is an indication that the ERST has been initiated.
1. THIS IS WHERE THE PREVIOUS MODELS DIFFER
6. Wait at least 2 minutes whilst the PCM goes through its ENGINE RUNNING SELF TEST MODE.
