## TECHNICAL BULLETIN

Document number: T0142

Model: RAV 4 / Avensis

Subject: Harsh gear shifting / thumping into gear

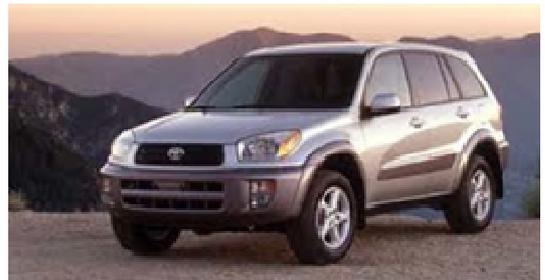
Some 2001 – 2003 model RAV4 vehicles equipped with an automatic transmission may exhibit a harsh shift condition during normal driving or even when putting into gear, and/or M.I.L. (malfunction indicator lamp) "ON". Upon checking fault codes, often the following DTC's are present: DTC P0750 (transmission shift solenoid A malfunction), DTC P0753 (transmission shift solenoid A electrical), DTC P0755 (trans shift solenoid B malfunction), DTC P0758 (transmission shift solenoid B electrical), and/or DTC P1760 (shift solenoid SLT malfunction) stored.

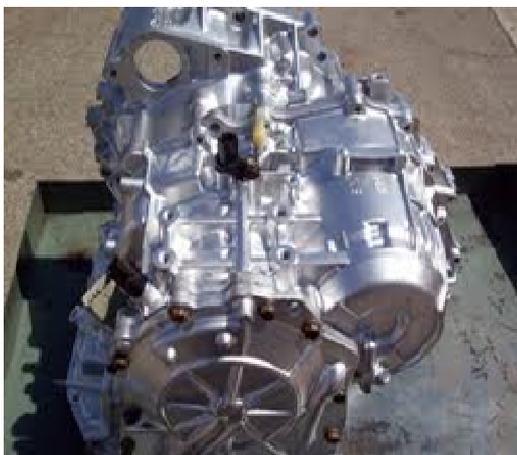
2001-2003 Toyota RAV4 Shift Solenoids Assy

Upon diagnosis, it has been found that the ECM does not fully release the (SLT) direct clutch solenoid. This clutch is applied on the 2nd to 3rd gear change. To test for this condition, connect a pressure gauge to the direct clutch pressure port. Shift solenoid SLT is used to alter fluid pressure to the direct clutch. When driving in 3rd gear there should be pressure (approx. 120 Psi) seen on the gauge. In 2nd and 4th there should be a zero pressure reading on the gauge. If there is any pressure seen on the gauge in 1st, 2nd or 4th, it is a sign that the ECM has failed. If it has slight pressure whilst in 1st, 2nd or 4th gears (3 to 20 PSI), it is enough to keep the direct clutch slightly applied and will cause it to eventually burn out.

Replace the ECM (situated behind glove box compartment) as per manufacturer instruction. Test drive the vehicle from cold to normal operating temperature to confirm fault has been rectified. If the fault condition is still present after replacing the ECM, the automatic transmission direct clutch assembly may also require replacement due to having been driven for too long whilst in a partially applied state. Injectronics are now able to bench test and repair customers own ECM's for the above mentioned fault, and also carry exchange ECM's in stock, which are supplied in an unlocked state (call Injectronics technical department for programming instructions). Injectronics have also found this type of fault to be common in Toyota Avensis and Tarago with the U241E transmission (2000-2004)
