## TECHNICAL BULLETIN

### FORD – FALCON EA MPI

#T0008

**Subject:** Acceleration problems

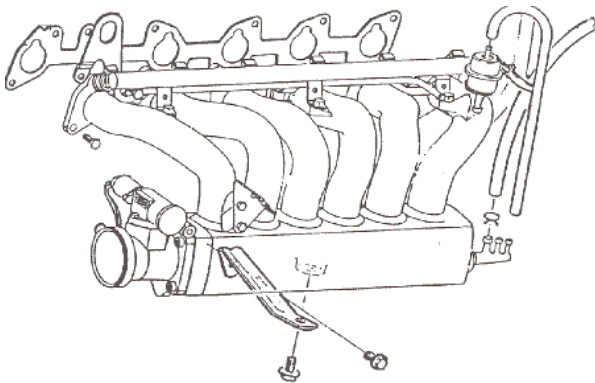
It has been found that the vehicle has had head or manifold work and the manifold re-assembled with a new gasket. However in these cases a CFI gasket was fitted instead of a MPI gasket. The CFI gasket does not have the cutaway for the injectors, so half the injector hole is covered which affects the spray pattern. If you suspect this, it may be quicker to remove the fuel rail and one injector. You can then see if the gasket is partially blocking the fuel injector hole (cutaway).
