TECHNICAL BULLETIN

Document number: T0028

Make: KE Laser / Mazda 323

Subject: No ignition

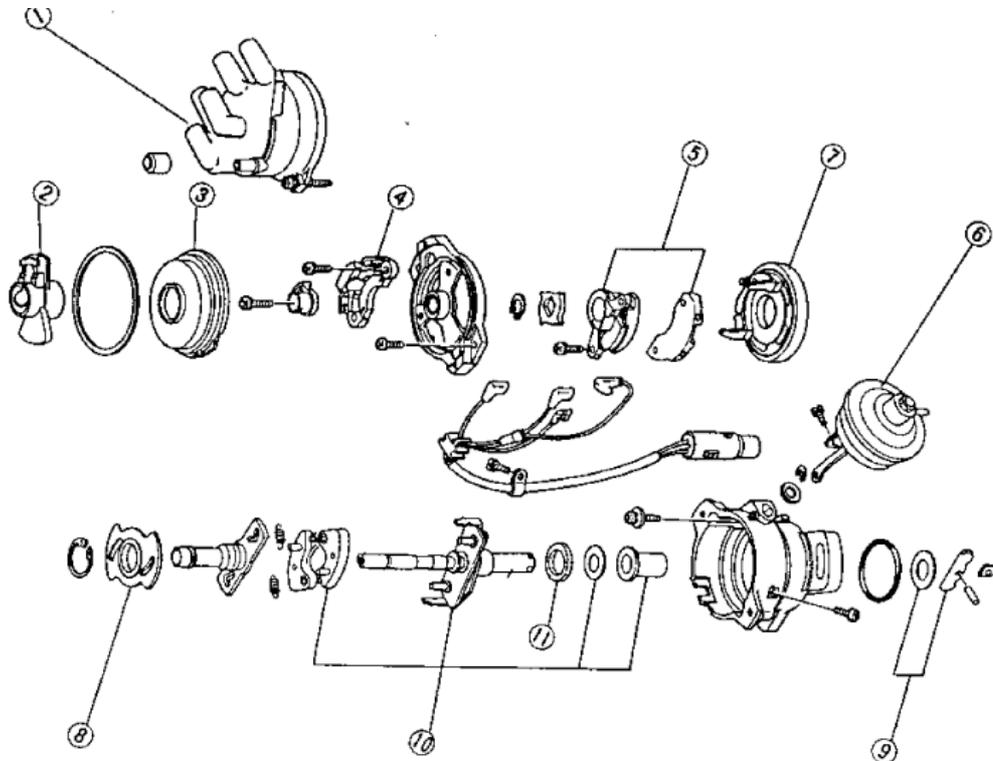
Injectronics has experienced a number of times, technicians fitting the incorrect parts to Ford / Mazda 1.6L turbo distributors causing no ignition. The distributor looks like it has 2 Ignition modules but in fact there are 2 sensors. The top sensor is a Mitsubishi J911 and it is called the G sensor. It has 2 terminals marked 'B' for battery power supply and 'G' for G sensor, which provides a pulsed earth as the distributor turns.

The bottom or lower module is only a terminal block and does not have any electronics in it. It is a direct connection to the inductive wheel sensor and windings and provides a terminal block for the wires going out of the distributor to the ignition / knock control module mounted on the drivers side ground.

Technicians often fit the J117 ignition module in place of the terminal block (as it looks identical) from non turbo distributors which will not operate. To check if the correct module / terminal block are fitted to the distributor, check there is continuity from the pickup winding terminal to the wire connection terminal on both sides of the module / terminal block.
