TECHNICAL BULLETIN

Document number: T0010

Model: EF Falcon / Fairlane / LTD (94 onward)

Subject: Ford service spanner indicator reset procedure

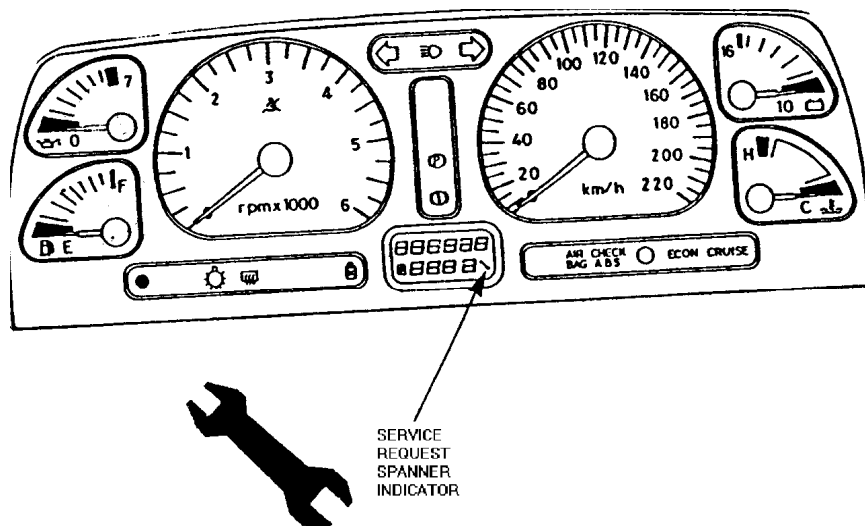
The instrument cluster fitted to the Ford EF Falcon / Fairlane / LTD range from 1994 onwards, had a liquid crystal display symbol in the shape of a spanner located beside the trip meter. The spanner symbol is displayed so as to remind the driver of the vehicles recommended service intervals.

To erase the service indicator symbol after a service, follow this procedure:-

1. Turn the key to the ignition on - engine off position.
2. Press the trip meter reset button and hold for 8 to 10 seconds.
3. The reset procedure is complete when a beep signal is heard and the spanner symbol is extinguished.
