#T0010

Make: Ford

Model: Falcon EF (94 onward)

Subject: Service spanner indicator reset procedure

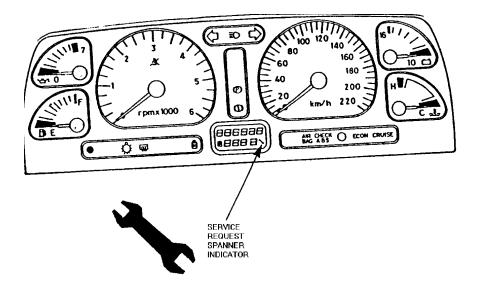
The instrument cluster fitted to the Ford EF Falcon / Fairlane / LTD range from 1994 onwards, had a liquid crystal display symbol in the shape of a spanner located beside the trip meter. The spanner symbol is displayed so as to remind the driver of the vehicles recommended service intervals.

To erase the service indicator symbol after a service, follow this procedure:-

- 1. Turn the key to the ignition on engine off position.
- 2. Press the trip meter reset button and hold for 8 to 10 seconds.
- 3. The reset procedure is complete when a beep signal is heard and the spanner symbol is extinguished.
