## TECHNICAL BULLETIN

Document number: T0142

Model: RAV 4 / Avensis

Subject: Harsh gear shifting / thumping into gear

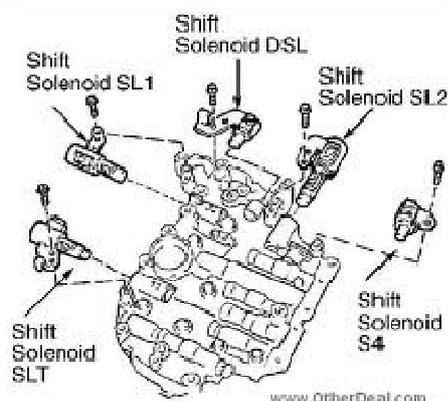
2001-2003 Toyota RAV4 Shift Solenoids Assy

Upon diagnosis, it has been found that the ECM does not fully release the (SLT) direct clutch solenoid. This clutch is applied on the 2nd to 3rd gear change. To test for this condition, connect a pressure gauge to the direct clutch pressure port. Shift solenoid SLT is used to alter fluid pressure to the direct clutch. When driving in 3rd gear there should be pressure (approx. 120 Psi) seen on the gauge. In 2nd and 4th there should be a zero pressure reading on the gauge. If there is any pressure seen on the gauge in 1st, 2nd or 4th, it is a sign that the ECM has failed. If it has slight pressure whilst in 1st, 2nd or 4th gears (3 to 20 PSI), it is enough to keep the direct clutch slightly applied and will cause it to eventually burn out.

Replace the ECM (situated behind glove box compartment) as per manufacturer instruction. Test drive the vehicle from cold to normal operating temperature to confirm fault has been rectified. If the fault condition is still present after replacing the ECM, the automatic transmission direct clutch assembly may also require replacement due to having been driven for too long whilst in a partially applied state. Injectronics are now able to bench test and repair customers own ECM's for the above mentioned fault, and also carry exchange ECM's in stock, which are supplied in an unlocked state (call Injectronics technical department for programming instructions). Injectronics have also found this type of fault to be common in Toyota Avensis and Tarago with the U241E transmission (2000-2004)
