# TECHNICAL BULLETIN

## HOLDEN CRUZE JG-JH SERIES - (ECM) ELECTRONIC CONTROL MODULE FAILURE DUE TO WATER DAMAGE

### Engine F18D4. Year 2009-onwards

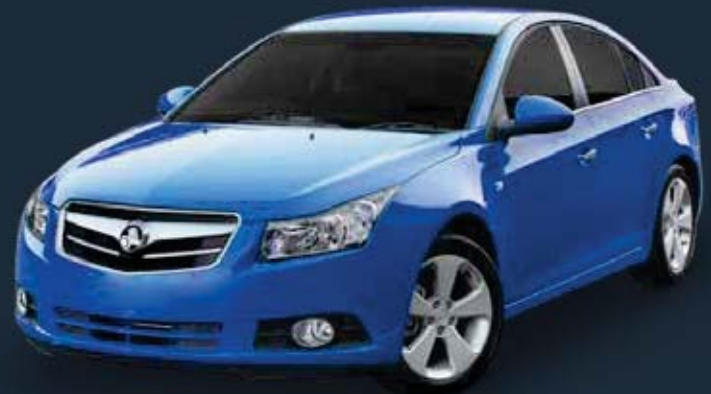
The ECM is mounted in the engine bay next to the battery and has two connector plugs which are not water tight. The connector sockets have copious amounts of dielectric grease, which is intended to protect the ECM from water ingress but this is ineffective.

The location of the ECM can be a problem when engine bays are steam cleaned before resale, repairs or after battery trays are cleaned when replacing a battery.

The simple solution is do not wash the engine bay on a Holden Cruze or any other vehicle otherwise the consequences can be dire.
