TECHNICAL BULLETIN

Document number: T0076

Make: Daewoo

Model: Cielo 1.5L 94-5

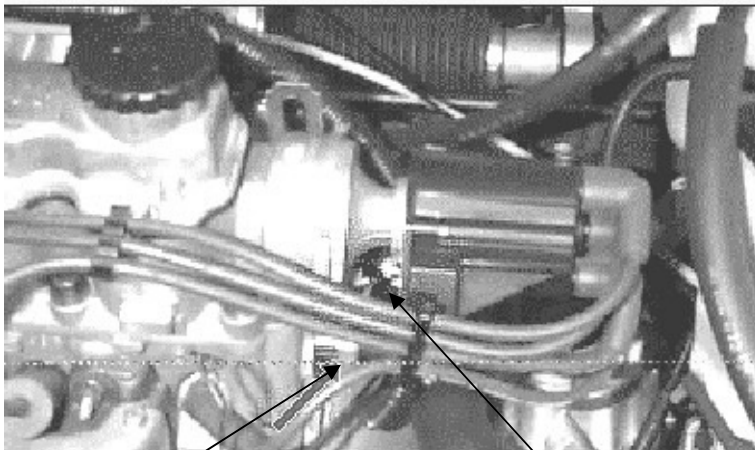
The problem was traced back to the coolant temp sensor and the distributor, they sit beside each other on the vehicle, both have identically shaped pin plugs, if the plugs are swapped around the vehicle will not start. The easy solution is swap the plugs back around, generally no damage occurs to the engine ECU, if any further problems occur the ECU can be tested by Injectronics.

Coolant sensor plug

Distributor plug
